Josephine Community Library Master Plan

Final Report

March 1st, 2019

WOLF CREEK LIBRARY Building Assessment

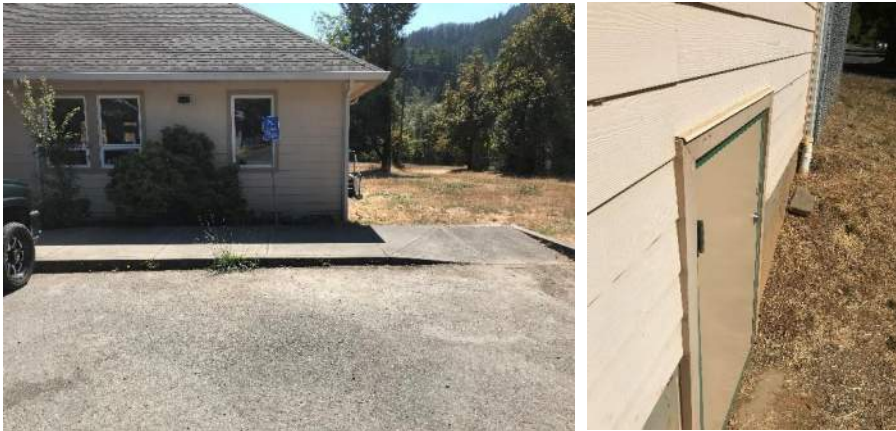
Figure 1

Landscaped area is only present at the front edge of library and has several dead and unhealthy plants. Library staff noted the irrigation system having problems and being of a rather unconventional installation (*see Figure 1*)

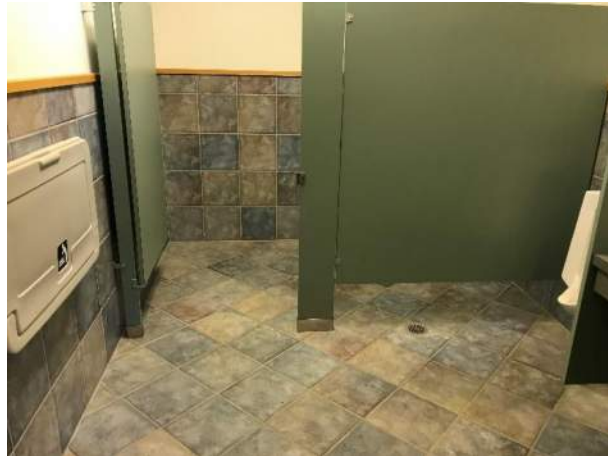
Figure 2

The building has 2 restrooms, each with two Water closets and 1 sink each that fully comply with ADA. Drinking fountain is also compliant with current ADA standards. Both restrooms have flat floors, and while do have floor drains in the event of water leak, which according to library staff has occurred in the past, the floors do not slope to the drains resulting in water seeping into the corridor. Clogged toilets also seem to plague staff. (see Figure 2)

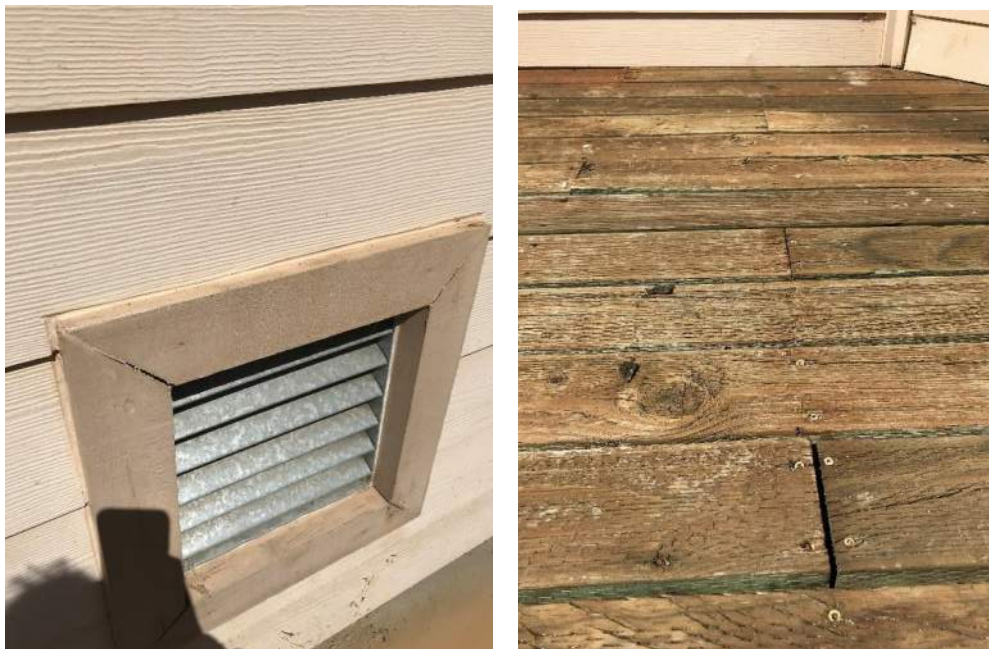
Figure 3

The deck off the rear of the reading room is the one few items in this library that is in poor condition. The deck consists of pressure treated support post and pressure treated decking. Support posts are in good condition, but decking is showing signs of rot, and some severe checking and splitting. Additionally, there are some areas where the siding is cut around the deck and not properly flashed. (see Figure 3)

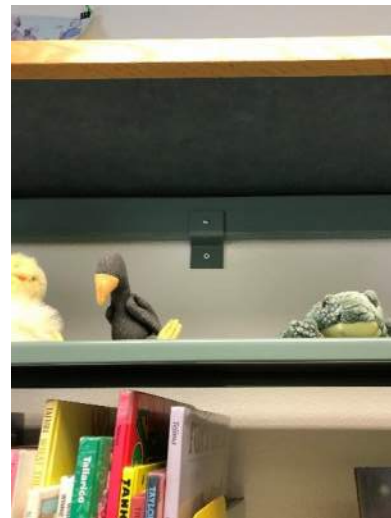
Figure 4

Free standing stacks appear to be secured to the floor and those placed against the wall are secured (see Figure 4).

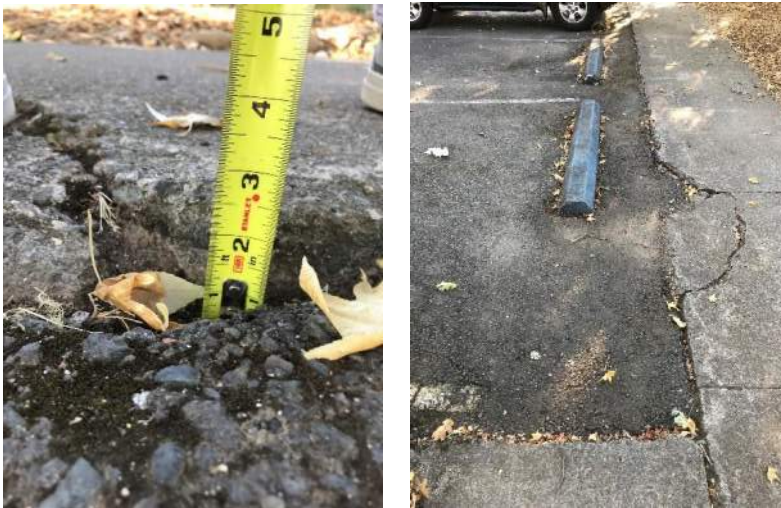
Figure 2

There is a loading drive on the west end of the library which appears sufficient for the library's current use. Sidewalk frontage is hampered by a continuous curb cut at the parking zone, resulting in a vehicular pedestrian conflict with vehicles backing out directly into the street. Additionally, the primary pedestrian access to the building entrance and adjacent to the book drop is a significant slope and suffers from settlement and cracking issues (see figure 2). Anecdotally library staff struggles with book carts to and from the book drop located at the street.

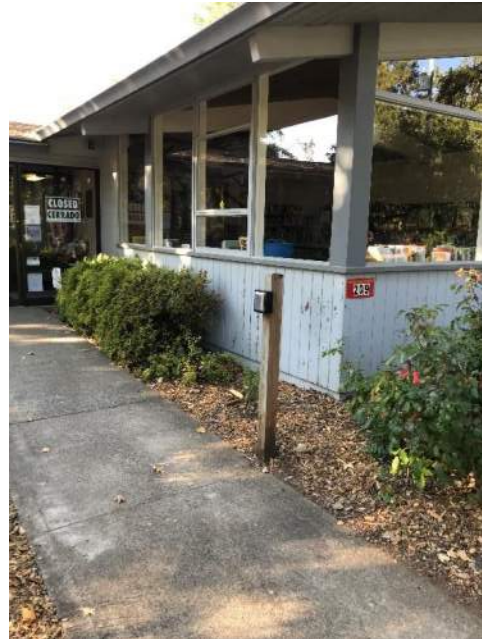
Figure 3

The primary entrance is equipped with a battery-operated ADA bollard mounted door operator. Staff has had to physically maintain this as it is battery operated. Aluminum entrance doors also stick at both the exterior door and the interior vestibule door hindering and increasing the wear on the door operators (see figure 3).

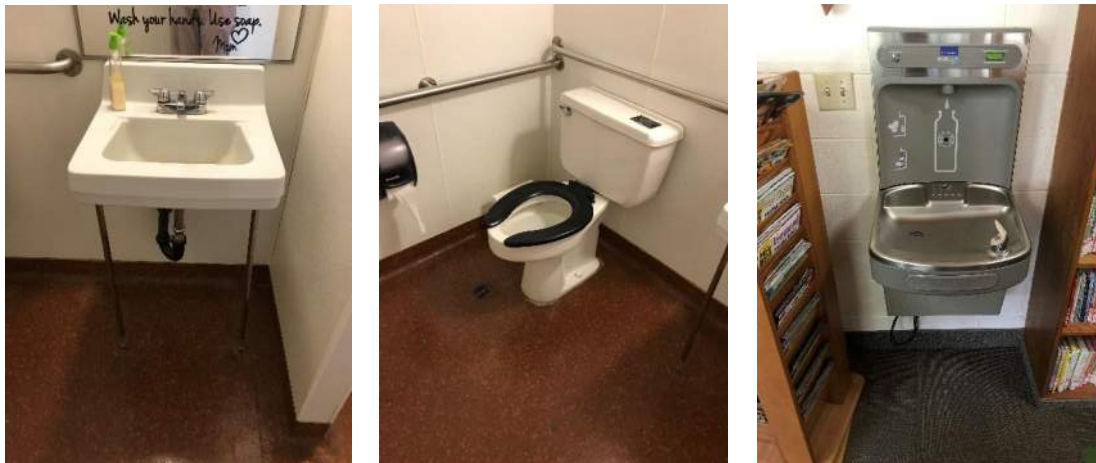
Figure 4

Two Public Restrooms appear to meet current size and access requirements. However; toilets, grab bars, and accessories do not meet current accessible heights. Additionally, the sink in both restrooms does not provide proper floor clearance or kneed clearance below the fixture. The single staff restroom does not meet accessible requirements. (See Figure 4)

A new drinking fountain has been installed complete with bottle filler. The fountain as installed meets all ADA requirements; however, the 30" clear floor space required for the drinking fountain appears to be encroached on by periodical rack and adjacent stack. (see Figure 4)

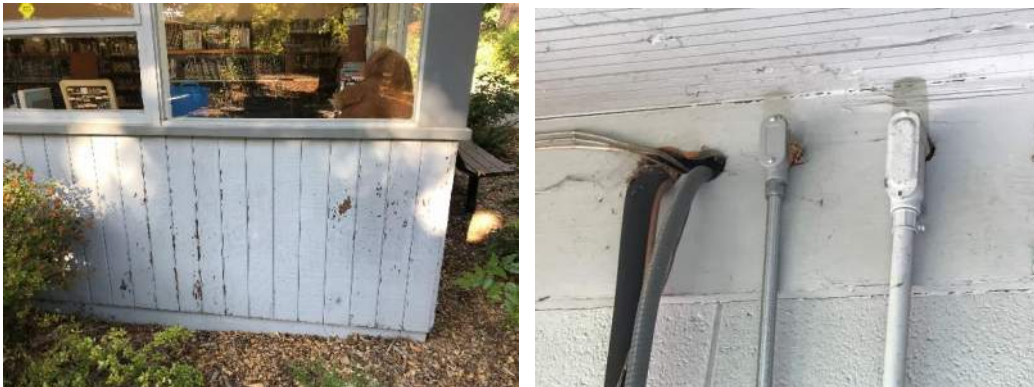
Figure 5

Framed walls are clad with 1x6 cedar vertical T and G siding installed over plywood sheathing and 15 lbs. felt for the addition. 1957 framed do not have a felt layer based on the record drawings for the building. The siding showed no visible signs of rot and was in relatively good condition. A significant crack does exist at CMU wall joint between the 1957 structure and 1978 addition. Crack does telegraph from the exterior to the interior, no visible signs of moisture or water damage are associated with the crack. Otherwise CMU walls are in generally good condition. Exterior paint is chipped and flaking, particularly at the wall base. Several electrical conduit penetrations at the south edge of the building are not properly sealed and present an air/moisture infiltration issue (*see figure 5*).

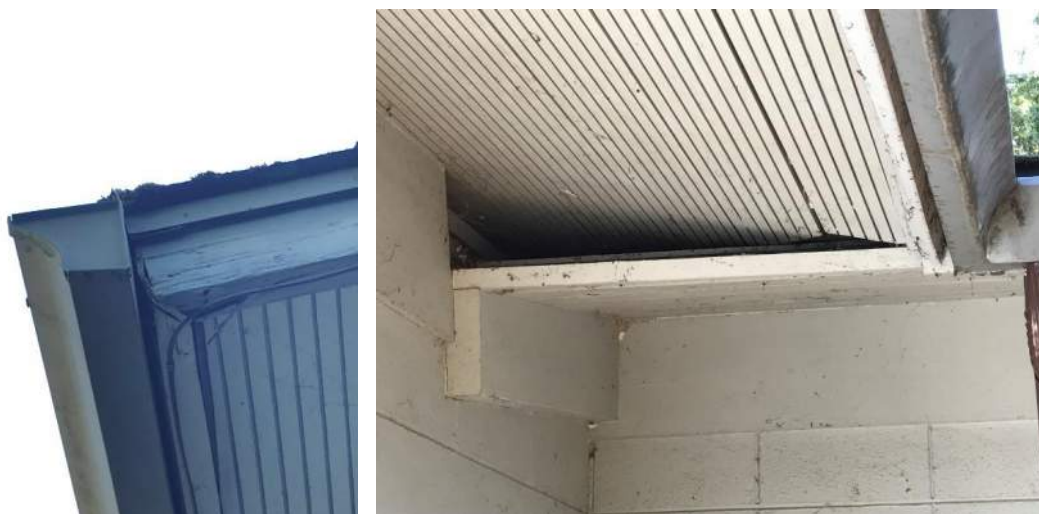
Figure 6

1998. The new roof was likely overlayed over the existing Built up roof. It is unknown without some selective demolition if additional insulation was added at the time of re-roofing. The roof has leaked and been patched within the last few years and visual inspection would suggest that it is at the end of its functional life. 20 years is the lifespan of a typical asphalt shingle roof. Additionally, the gutter on the south side is bent and does not slope appropriately to downspouts. Several Fascia locations at the SW and SE corners show severe rot. There is a soffit board missing at the east edge of the Media room addition where the meets the existing building. The missing fascia poses an air infiltration and possible pest control issue within the building. There were Rodent Feces evident within the

interior soffit area at the media room. (see Figure 6)

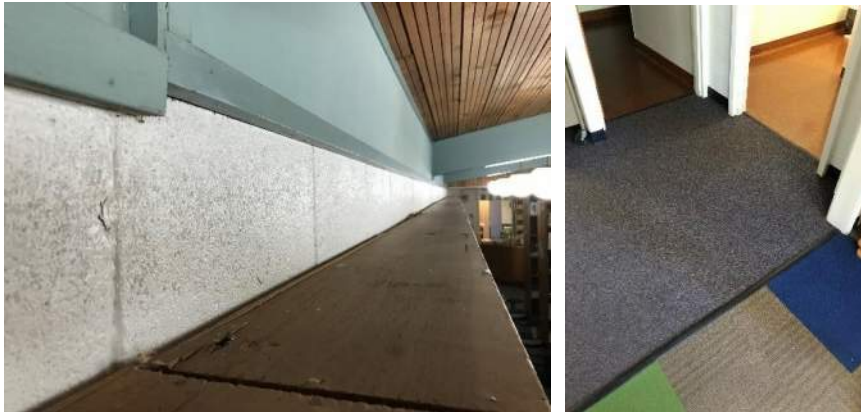
Figure 7

The interior finishes consist of exposed CMU walls, wood paneled ceiling and walls where no CMU is present. There are limited areas of dropped Gypsum board ceilings and some areas of adhered acoustic ceiling tile ceiling. Broadloom carpet is present in majority of the library apart from carpet Tile in the children's wing. Broadloom is relatively worn and based on staff anecdotes has not been replaced in quite some time. Additionally it was noted by Library staff that there is VCT tile under. Children's area carpet tile is new and in good shape as is the paint in that wing. When replaced Asbestos abatement was required of the VCT tile at that time. It is wise to assume that a similar abatement would need to occur for VCT tile under broadloom carpet as well.

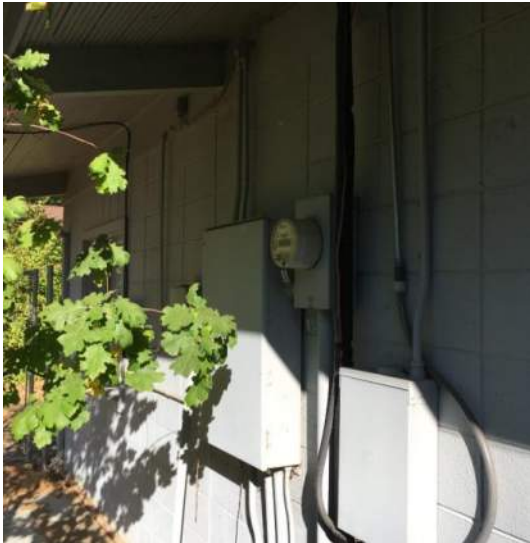
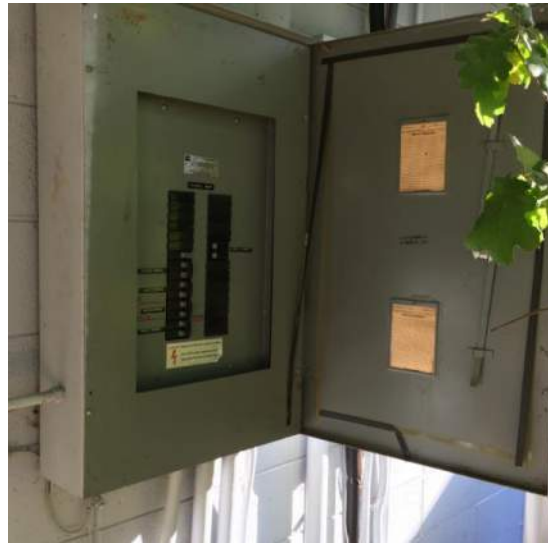
The service panel and sub-panels appear to have been installed in the same era as the 1978 wing addition. The service panel and is in fair-to-poor condition and is expected to near the end of its useful life. The existing sub-panels are in slightly better condition, but are also near the end of their useful life.

Branch circuiting is a combination of wiring in conduit, and older vintage paper sheath cabling in the attic and walls. Surface raceway is installed in the computer lab area, and convenience power is lacking within the open stack areas.

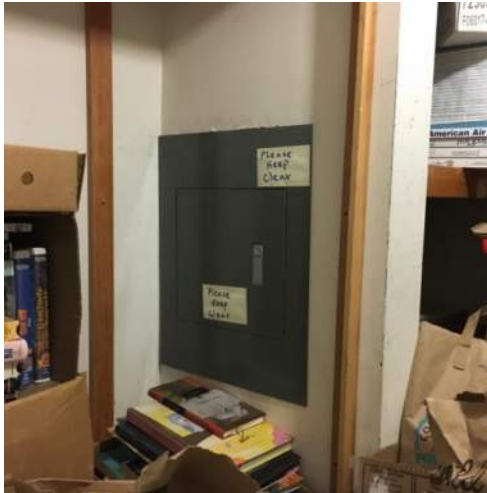
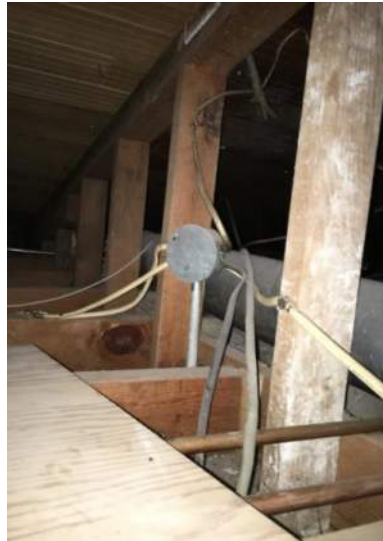
The service panel and exterior sub-panel doors are bolted shut with non-factory hardware that is field-installed, which allows the circuit breakers to be accessible only with the use of tools.

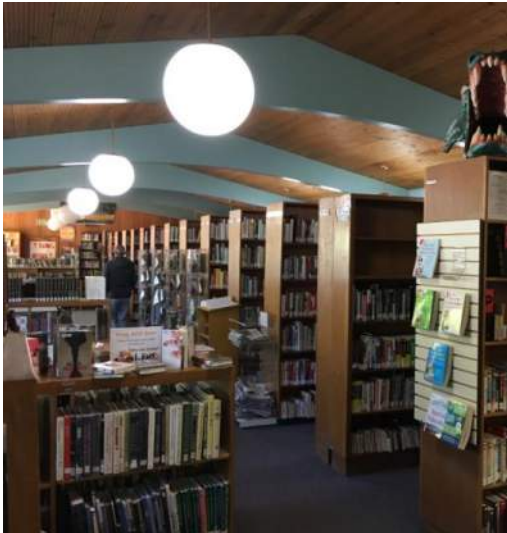
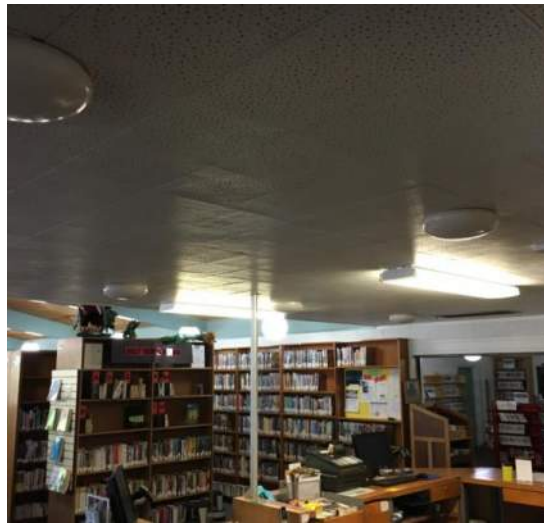
The existing lighting is aged and at the end of its life. Lamp sources are non-efficient and out of date, and several fixtures are in poor condition, some with significant lens damage or no lens on the fixture.

Light levels at the main stacks is visibly low. No exterior lighting is present at walkways or parking.
