Josephine Community Library Master Plan

Final Report

March 1st, 2019

WOLF CREEK LIBRARY Building Assessment

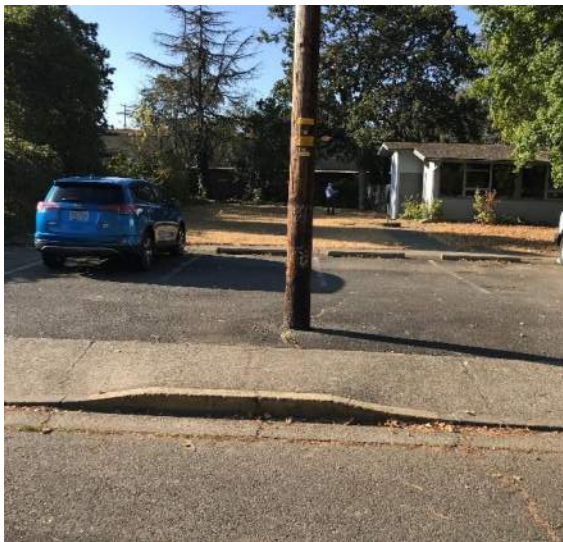
Figure 1

Parking consists of 12 total spaces with direct pull directly off Palmer street. Layout results in poor parking efficiency as vehicles back directly into traffic 1 spot is severely hampered by existing Utility Pole in the right of way, resulting in insufficient access if adjacent vehicles are present. There are (2) signed ADA parking spaces; neither of which meet current Accessibility standards per Oregon Structural Specialty Code. All stalls are poorly striped. (see figure 1)

City of Cave Junction requirements do not specifically cover municipal uses as it is subject to City Council review, yet the requirements for a commercial or retail space and or place of business, most similar to a library stipulate a 1 parking stall per 350 SF of building. Libraries in Grants Pass are 1 stall per 500SF for reference. The 12 spaces supplied are compliant with this standard. Current Code allows only 1 space to be ADA compliant for up to 25 parking spaces. Currently neither spot indicated as ADA is compliant.

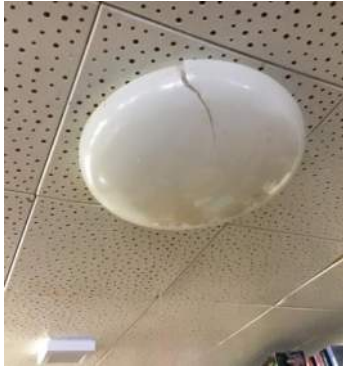
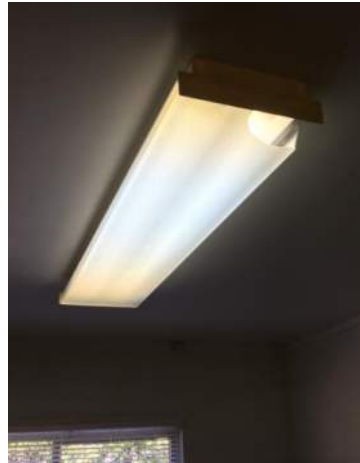
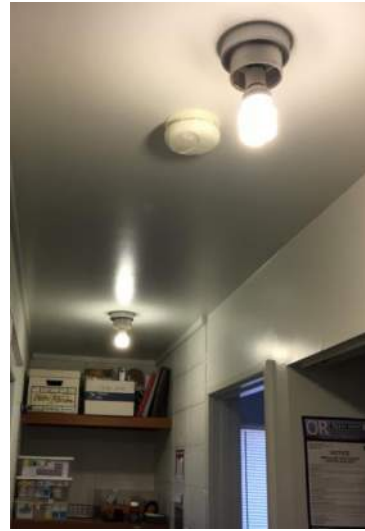
The existing lighting is aged and at the end of its life. Lamp sources are non-efficient and out of date, and several fixtures are in poor condition, some with significant lens damage or no lens on the fixture.

Light levels at the main stacks is visibly low. No exterior lighting is present at walkways or parking.

Egress lighting and exit signs appears to be sourced by the main normal power service, with no battery pack egress lights or exit signs installed.
